Machine condition information... a valuable resource for strategic management decisions

by Monroe Miller
Predictive Maintenance
Specialist
Maintenance Technical
Services Division
Montell USA Inc.
Lake Charles, LA.

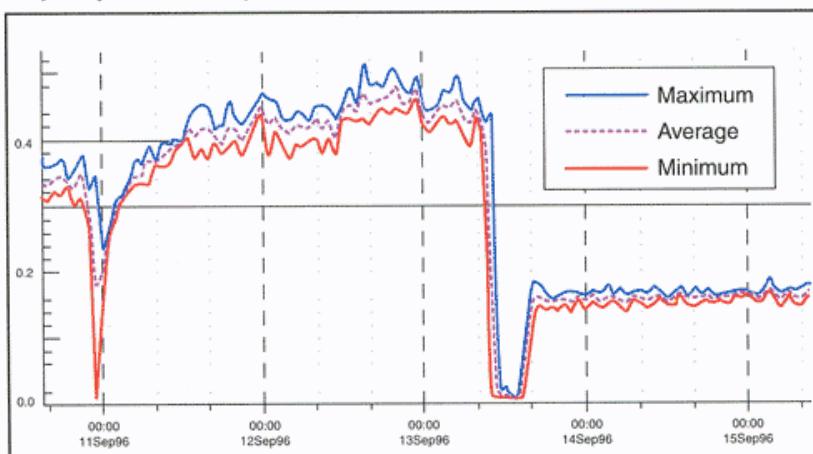
Trended data was also reviewed, and it was noticed that whatever was happening was progressive (Figure 2). Looking at the data, it was believed that the real "culprit" was the coupling, and it was decided to pull the coupling. That's exactly where the problem was. Three of the six coupling hub retainer bolts had broken and the remaining three bolts had been sheared off.

Figure 2. Vibration trend showing effect of damaged coupling and response after its repair.

The problem was spotted very quickly and fixed in just 5 hours. If
